TECHNICAL REPORT HL-90-19

# A STUDY OF VEGETATION ON REVETMENTS SACRAMENTO RIVER BANK PROTECTION PROJECT

## PHASE 1

## LITERATURE REVIEW AND PILOT STUDY

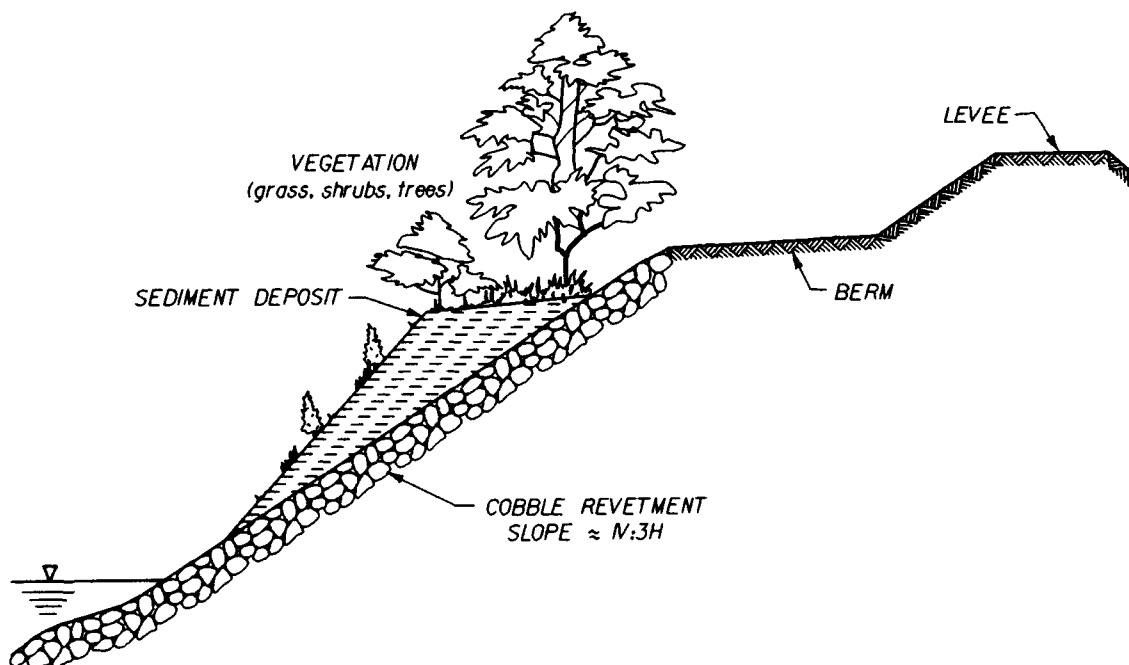
Longitudinal berms of silt and clay sediments occurred on many of the revetted banks in the pilot reach, as shown in Figures 14 and 15. These wedge-shaped (in cross section) deposits were also found on unprotected banks and were extensive enough to represent a significant sediment storage location. The deposits generally had well-defined upper and lower boundaries, the elevations of which may be related to stages with specific durations. Harvey, Watson, and Schumm (1989) stated that specific gage, area, and velocity analyses suggested that these sediment deposits were gradually reducing low-flow channel conveyance. A similar effect on high-flow conveyance was not observed.

Figure 15. Cross section through a typical vegetated sediment deposit on a cobble revetment

Most of the cobble revetments were covered with wedge-shaped sediment deposits as shown in Figure 15. The faces of the wedges extended from near

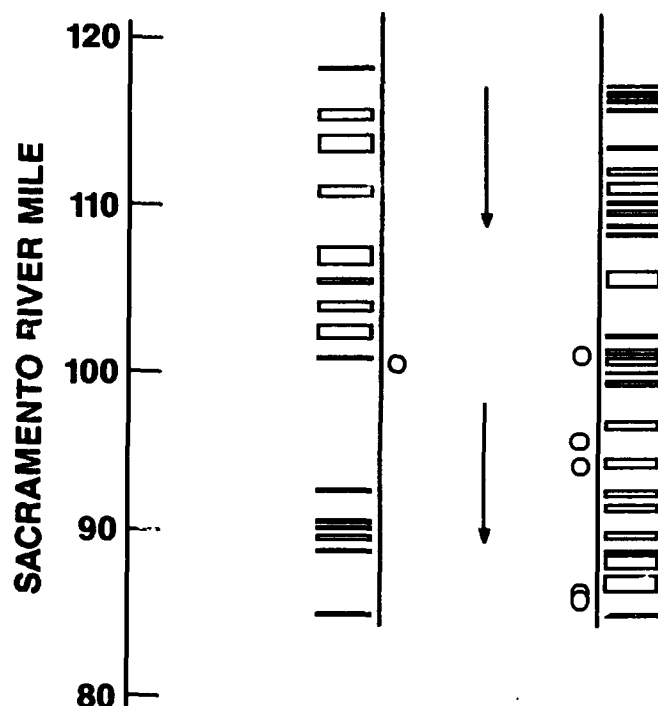
Not counting 84.6 to 85.4L, 92 percent of the damaged segments were riprap revetments located on convex banks. Aside from 84.6 to 85.4L, 96 percent of the damaged segments were constructed subsequent to 1970. All of the damaged sites were located below mile 100, and 50 of the 54 damaged segments were on the left bank (Figure 25).

Figure 25. Schematic of pilot study reach, Sacramento River, showing PL-99 damage sites and preflood revetment vegetation from aerial photographs

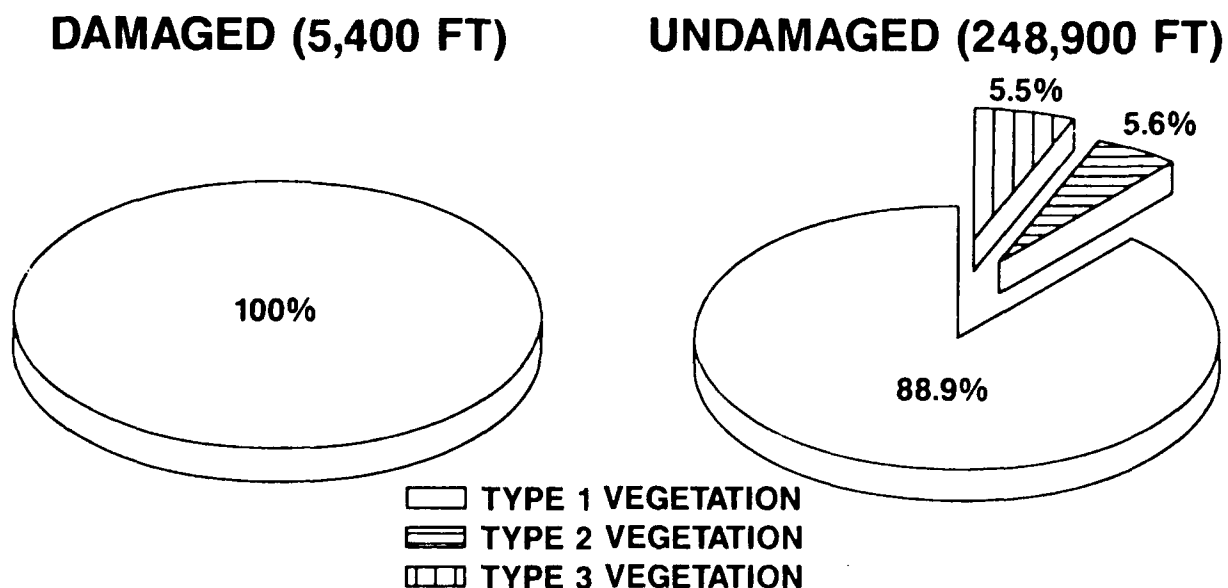
Vegetation types for undamaged and damaged revetments are compared in Figure 26. None of the four sources of information about revetment vegetation indicated any woody vegetation on any of the damaged segments before or after the 1986 flood. Accordingly, damage rates for unvegetated sites were higher than for vegetated ones. Damage rates for various revetment categories are presented in Table 15.

Figure 26. Distribution of vegetation types on damaged and undamaged revetments

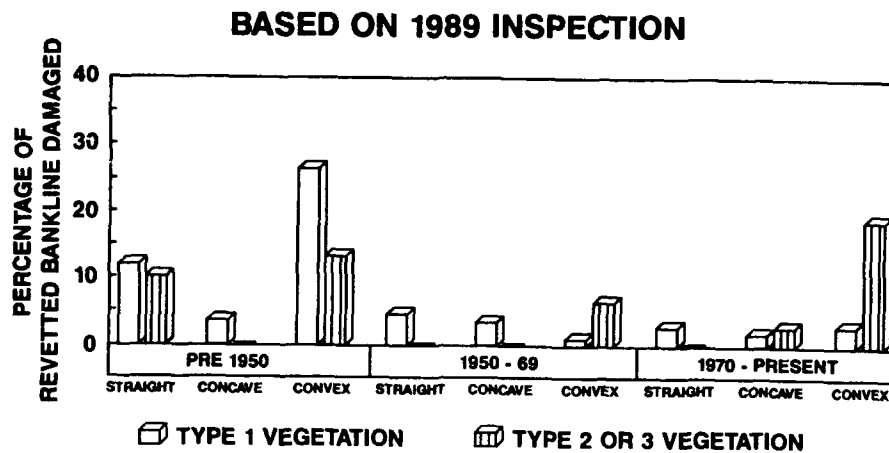
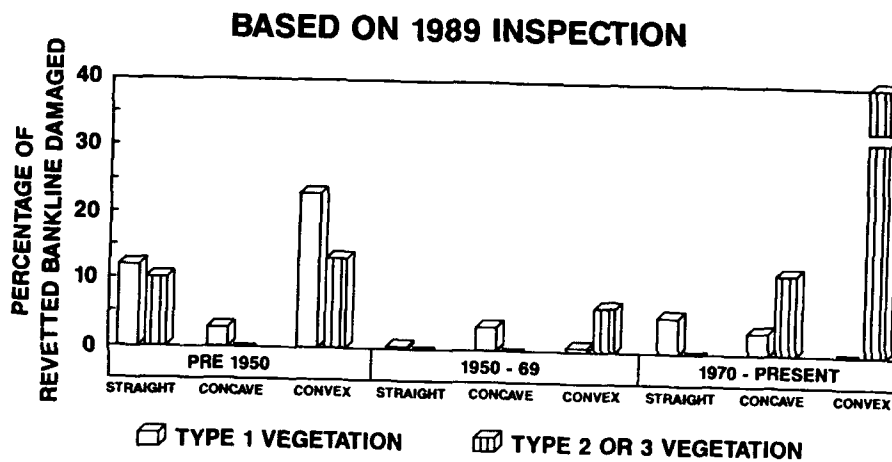
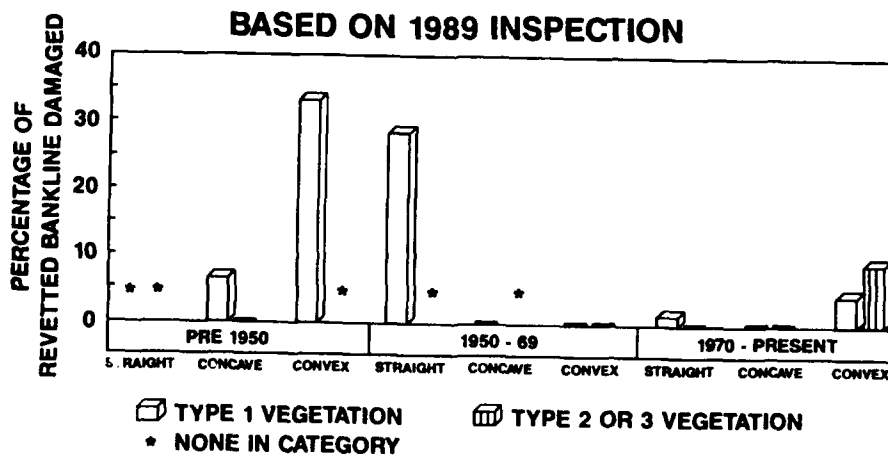
Damage rates for revetments supporting Types 2 and 3 vegetation were 5.4 and 9.5 percent, respectively, which compares to only 3.3 percent for those supporting Type 1 vegetation. However, this association between woody vegetation and damage is due to the association between revetment age, bank curvature and damage. To better assess the nature of the association between vegetation and revetment durability, a cross-tabulation of data base 2 (1989 conditions) was performed using two vegetation classes (Type 1 and Type 2 or 3), two damage classes (undamaged or damaged), three bank curvature classes (straight, concave, and convex), and three age classes. This cross-tabulation was run for all revetments, for cobble revetments only, and for rock riprap revetments only. Results are shown in Table 17 and Figure 27. Vegetated revetments performed as well or better than unvegetated revetments in seven of nine categories when all types of material were considered. Vegetated cobble revetments performed as well or better than unvegetated in six of nine

categories, and vegetated riprap revetments performed as well or better than unvegetated in five of six categories. When vegetated and unvegetated revetments of similar age and with similar locations within bends were compared, vegetated revetments were less likely to be classified as damaged than unvegetated revetments.

Figure 27. 1989 revetment damage rates for vegetated and unvegetated revetments

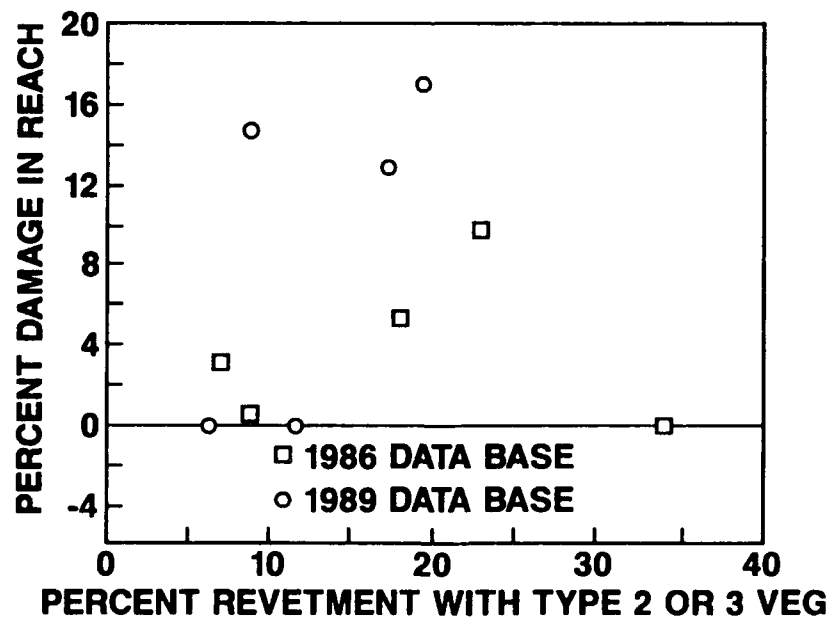
Results obtained from cross-tabulation analyses of the two data bases are compared in Table 18. The 1989 data base includes more damage and more types of damage situations, although it does not provide any information about structure performance under a given set of hydraulic conditions. Aside from 84.6 to 85.4L, the PL-99 data base emphasizes damage to relatively new rock riprap sites on convex bank. The 1989 data base records damage to old cobble sites that was not recorded in PL-99 files. Many of these sites are located on concave bend exits or convex bend entrances. Both data bases revealed that older revetments were more likely to support woody vegetation (Figure 28). Both also indicated no relationship between the amount of vegetation and the amount of damage in a WET subreach (Figure 29).

Figure 29. Damage and vegetation rates by WET subreach

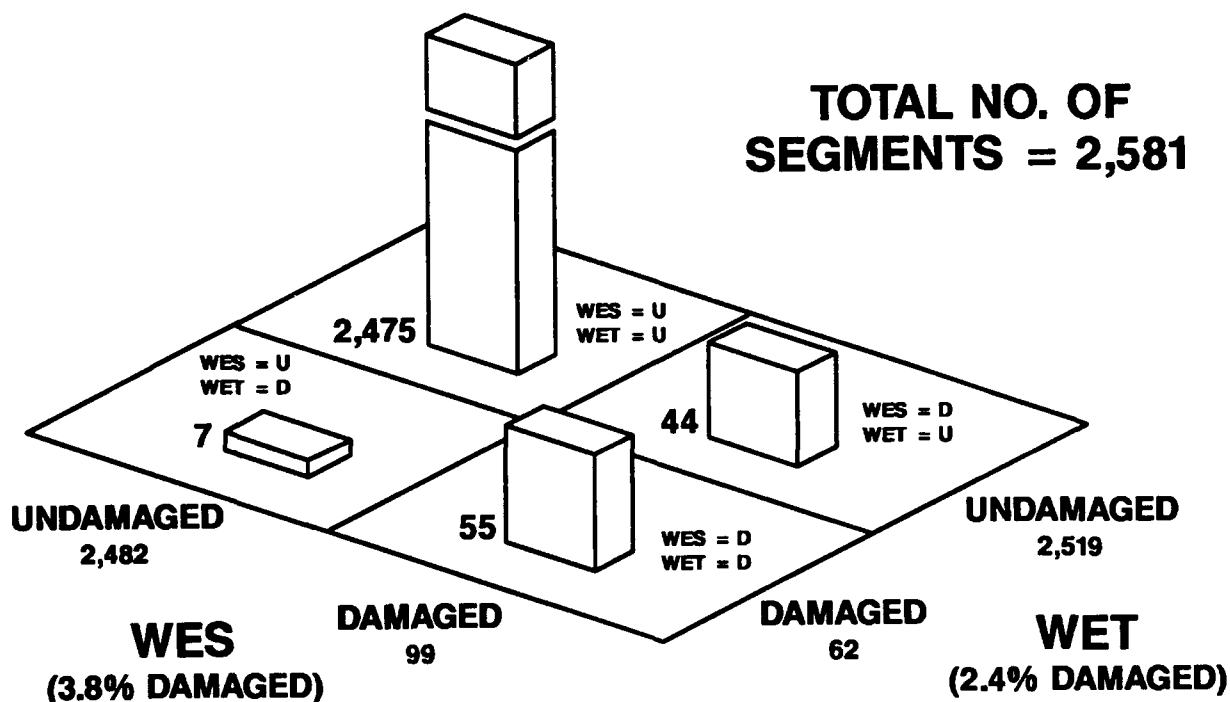
on the WET field notes from April 1989. Comparison of the two damage tallies is provided in Figure 30. Essentially all of the WET damage was included in the WES September inspection results, and 44 additional 100-ft segments were also identified as damaged. The seven segments classified as damaged by WET but undamaged by WES were due primarily to subjective differences.

Figure 30. Comparison of WES and WET revetment damage tallies for pilot study reach, Sacramento River. Of the 99 100-ft segments classified as damaged by WES investigators in September 1989, 55 were also classified as damaged on WET field notes from April 1989. The remaining 44 were not shown as damaged on WET notes
